To: All repair centres and production sites
Copy to: Anyone working with ND-120-CPU
From: Lasse Brataas
Date: 18 November 1994

Subject: NEW BACKUP BATTERY FOR THE CALENDAR ON ND-120-CPU

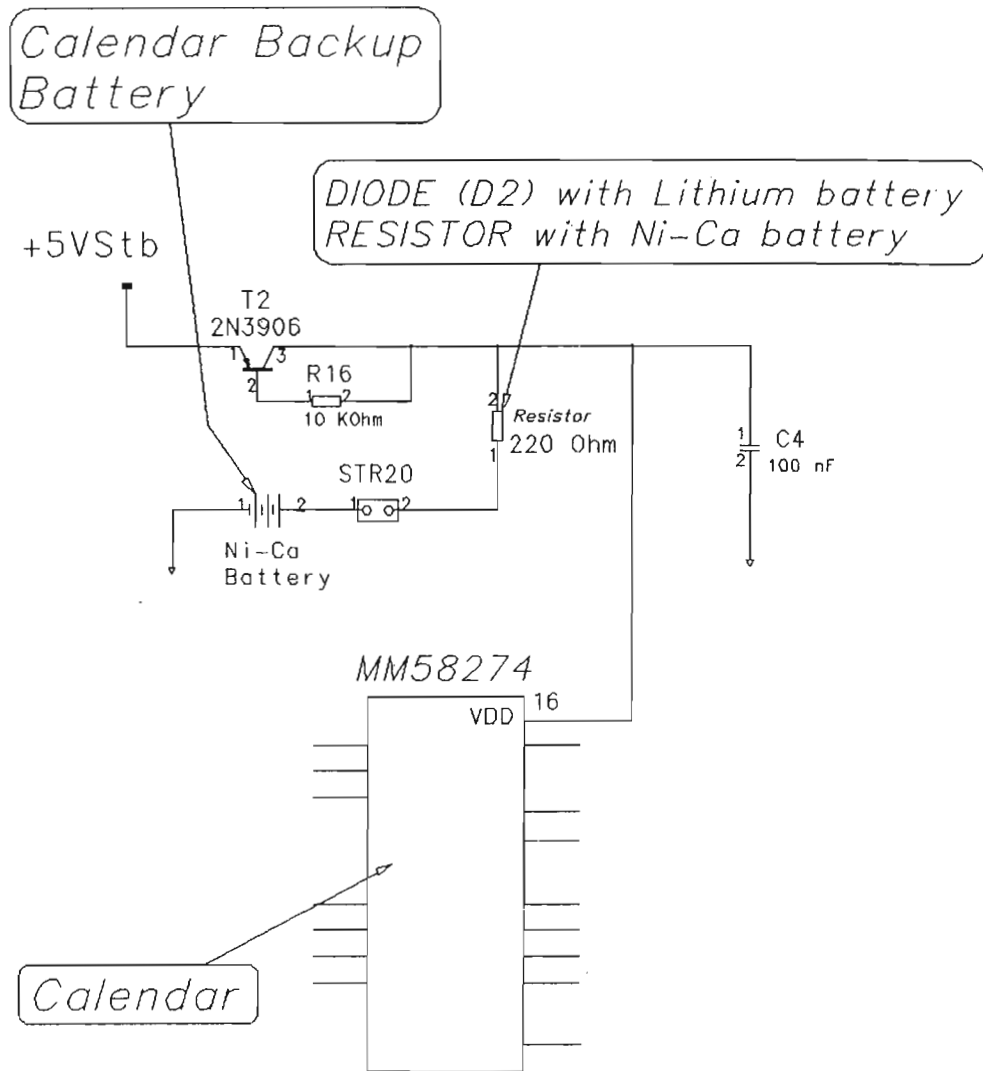
Detail of the logic diagram of print 3202.

There will be a change in production of the ND-120-CPU from approximately the end of November this year. The calendar on the ND-120-CPU will be supplied with a new type of backup battery. The function of the backup battery is only to supply power to the calendar when the +5VStb is lost, such as during very long power-cut (more than 10 minutes), or when the CPU is in storage. See the detail from logic diagram on page 3.

WHEN THE CPU IS MODIFIED, (DIODE D2 IS REPLACED BY A RESISTOR), YOU MUST NEVER TRY TO INSTALL THE "OLD" BATTERY AGAIN. THIS WILL CAUSE CHARGING OF THE LITHIUM BATTERY WHICH MAY CAUSE A BIG EXPLOSION.

The "OLD" battery has part number: 512022
The "NEW" battery has part number: 507040
